Additional LKM Fix**Symptoms:**

Headlights randomly turning off (even while driving)

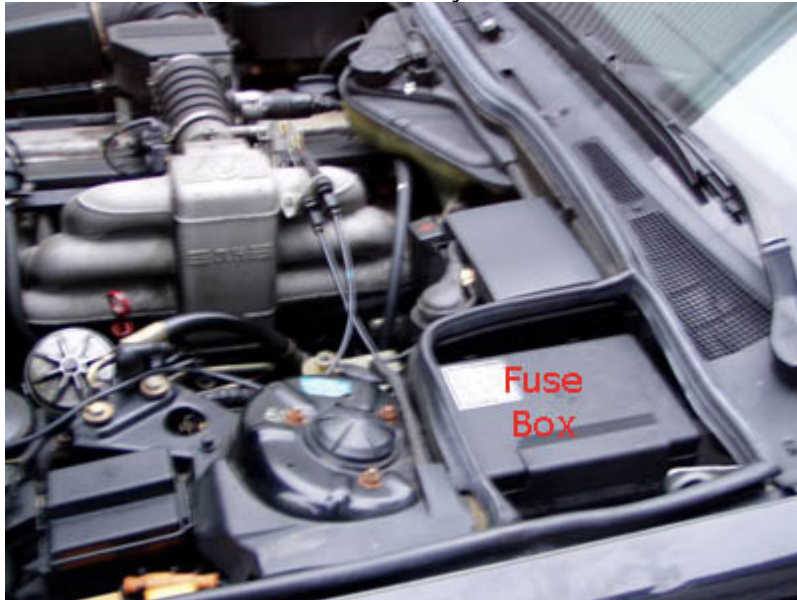
The fuse box is located on the driver side just in front of the winshield.

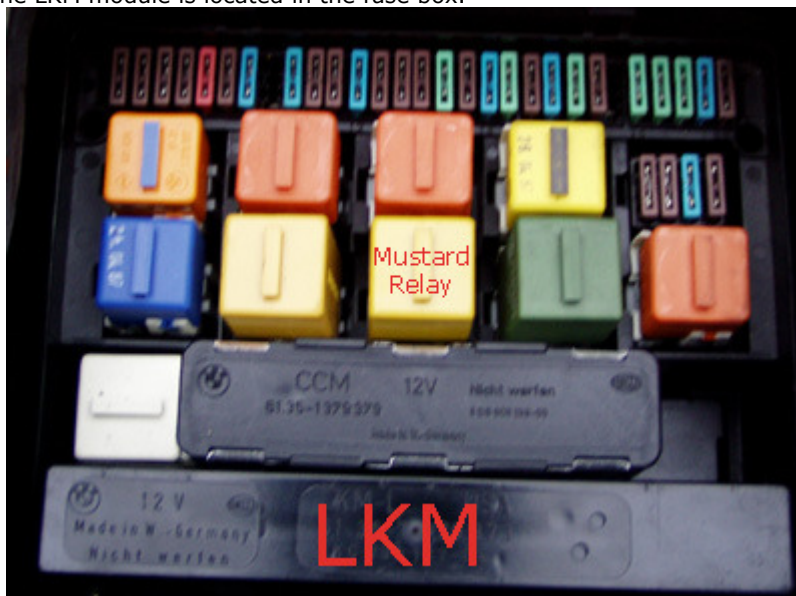
The LKM module is located in the fuse box.

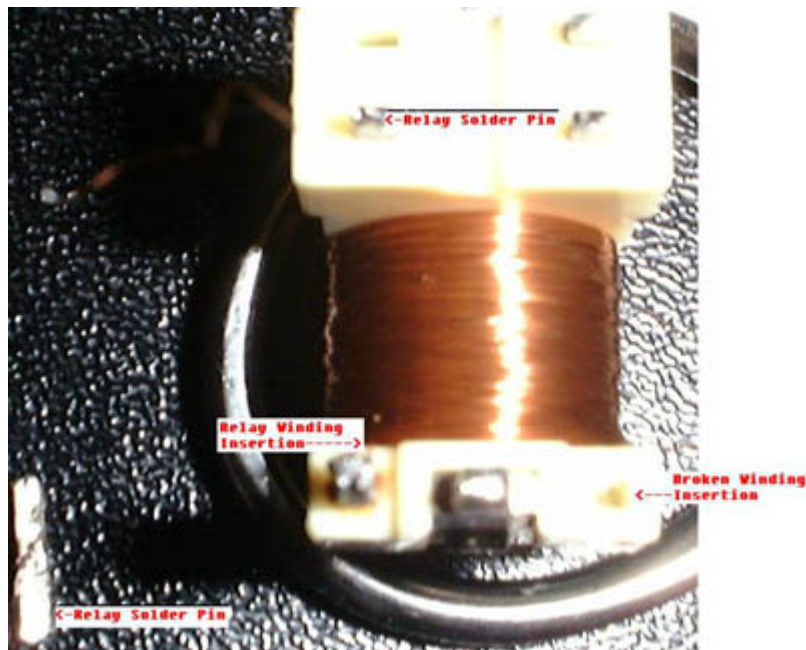
After I desoldered all the relays from the LKM circuit board this is what I found:

When I started removing solder joints with a vacuum desoldering tool, pins that attach the relay to the PCB started coming out. You can see one in the lower left hand corner of the image above. If you look carefully at the relay, you can see that one end of the relay's copper winding terminates on the left pin, but you can't see the wire that is supposed to terminate on the right pin (the one that's missing). That's because it broke and is too short to fit in the insertion hole. In the image below, you can see the broken wire AFTER I've unwound one turn of it to create enough slack to stuff it back down the insertion hole on the relay. NOTE: Make sure you leave enough slack in the wire so that it won't break when the tension on it increases as you reinsert the pin that attaches the winding to the circuit board. Too much slack and it might move around enough to short against something. That is what we'll call "a Bad Thing", it's an industry term.

Anyway, basically you're going to desolder all the relays and CAREFULLY remove them from the PCB. Remember that there's some other solid state stuff on this module so Static is your enemy. Ground yourself, especially during these winter months when dry air is a common threat. Once you've done that, turn the relays over and look at the pins under magnification to identify the ones with winding terminations. Check them for continuity and if broken, unwind them one turn and trim to proper length, insert wire into pinhole, and stuff the pin back in. In my case, this was easy because the pins came out as I was desoldering them. If yours didn't, you can heat the pin and extract it with needle nose pliers (I used a Mayo clamp).

Resolder the relays making sure that you cleaned the contact area on the PCB of old solder, let cool, and reassemble the module and plastic cover. MAKE SURE there's no loose balls of solder rolling around in the plastic cover, because you just know they will find a way to short something out.

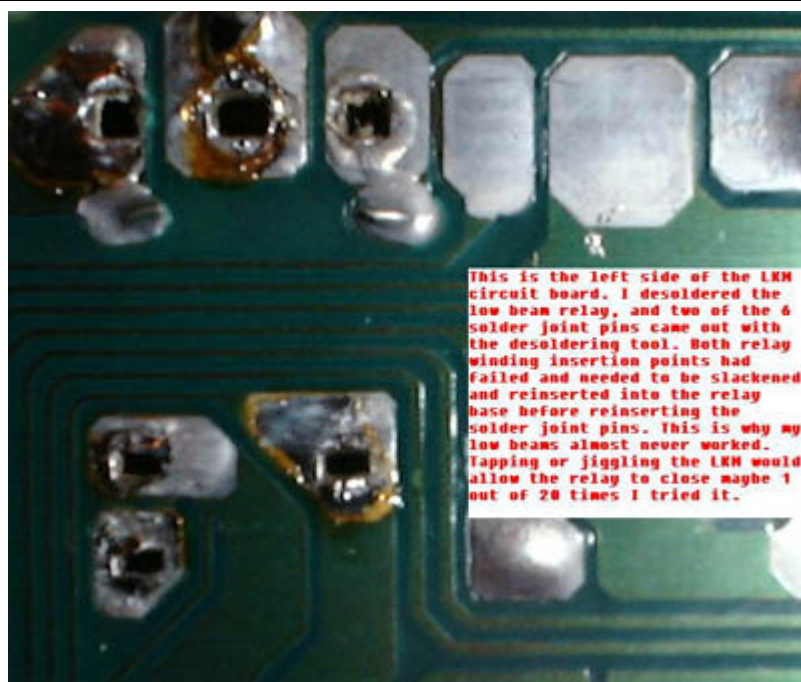
Here's what my LKM looked like after I desoldered the three relays (High, Low, Fog). Note: some LKMs have 4 relays, mine has three. Yes, it came that way. Note that the annotation on the next image is wrong, there are relays for high, low, and fog. Not 2 for high beams as is indicated here.

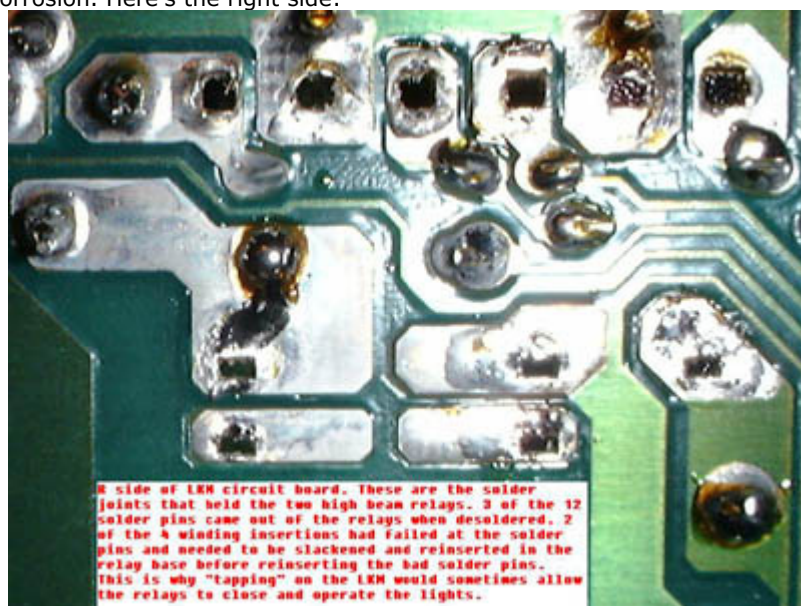
Notice the brown crap on the joints. That's melted varnish and solder, not corrosion. Here's the right side:
